# Citizen's Constituency Development Fund Report Card for Bumula Constituency Bungoma County

- This Citizen's Report Card presents findings from research in Bumula Constituency. The report covers one government Financial Year 2007/08. The NTA has not researched the 2008/09 Financial Year as much of the funds have not been spent to date.

Project Classification Summary Tables,  
Project Profiles and digital photographs  
for all CDF projects visited and assessed in  
the Financial Year (FY) 2007 - 08

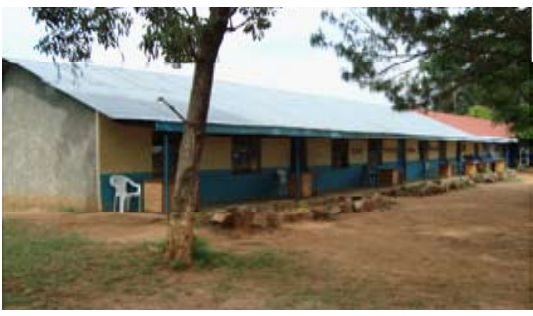
<b>Project Number</b>	CDF/B/001/2007-08

<b>Constituency</b>	Bumula		
<b>Project Name</b>	Mukhuma R.C Primary School		
<b>Project Activity</b>	Construction of 3 classrooms		
<b>Location/Ward</b>	Kabula		
<b>Date of Assessment</b>	25/02/2010.		
<b>Total Funds Awarded to Date</b>	700,000		
<b>Total Funds Spent to Date</b>	700,000		
<b>Total Unaccounted Funds</b>	0		<b>Project Category</b> A
<b>Technical Performance Score</b>	80%		<b>Project Status</b> Complete and in Use
<b>Comments:</b> Good quality materials were used, finishing and fittings were fairly done and the cost was within the estimates. There is value for the taxpayers money.

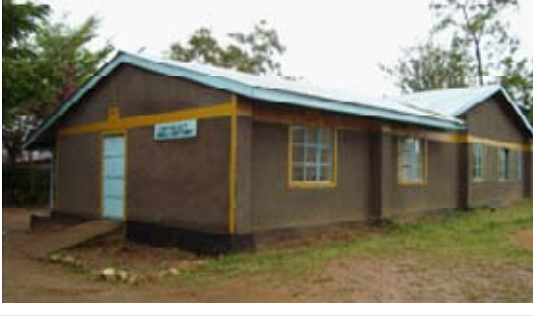
<b>Project Number</b>	CDF/B/007/2007-08

<b>Constituency</b>	Bumula		
<b>Project Name</b>	Talitia R.C Primary School		
<b>Project Activity</b>	Construction of 3 classrooms		
<b>Location/Ward</b>	Kabula		
<b>Date of Assessment</b>	26/2/2010.		
<b>Total Funds Awarded to Date</b>	500,000		
<b>Total Funds Spent to Date</b>	500,000		
<b>Total Unaccounted Funds</b>	0		<b>Project Category</b> A
<b>Technical Performance Score</b>	86%		<b>Project Status</b> Complete and in use
<b>Comments:</b> A well implemented project whose cost was within the budget. The community participated by providing unskilled labour and hard core. The fascia board, windows and doors were well fixed and painted. Materials used were of good quality. This project reflects good value for money.

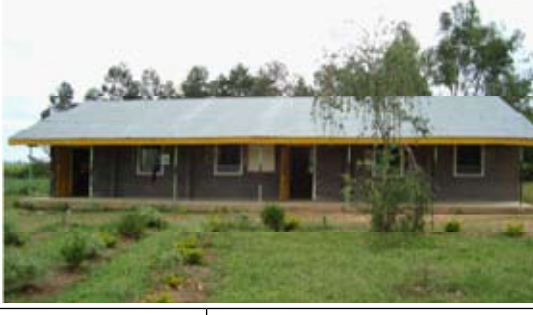
<b>Project Number</b>	CDF/B/008/2007-08

<b>Constituency</b>	Bumula		
<b>Project Name</b>	Naburereya R.C Primary School.		
<b>Project Activity</b>	Construction of 2 Classrooms		
<b>Location/Ward</b>	Kabula		
<b>Date of Assessment</b>	3/3/2010		
<b>Total Funds Awarded to Date</b>	800,000		
<b>Total Funds Spent to Date</b>	800,000		
<b>Total Unaccounted Funds</b>	0		<b>Project Category</b> A
<b>Technical Performance Score</b>	83%		<b>Project Status</b> Complete and in Use.
<b>Comments:</b> The fascia board and the support pillars for this project were well fixed although the roofing timber was not treated. The classrooms are of standard size. Doors and windows are durable as they are made of steel. The Verandah was well done and supported with steel. The project was well implemented and the community is making use of the facility.

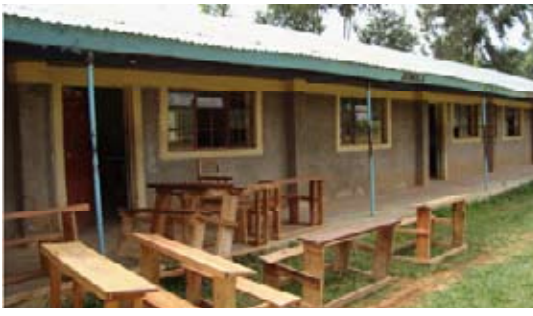
<b>Project Number</b>	CDF/B/010/2007-08

<b>Constituency</b>	Bumula		
<b>Project Name</b>	Wamumali R.C primary School.		
<b>Project Activity</b>	Construction of 3 classrooms		
<b>Location/Ward</b>	Kabula		
<b>Date of Assessment</b>	06/09/2010		
<b>Total Funds Awarded to Date</b>	700,000		
<b>Total Funds Spent to Date</b>	700,000		
<b>Total Unaccounted Funds</b>	0		<b>Project Category</b> A
<b>Technical Performance Score</b>	56%		<b>Project Status</b> Complete and in use
<b>Comments:</b> For this project the roofing timber was treated. The fascia board was fitted although it has several bends. Steel windows with glass were also fixed. Plastering was done inside the classrooms. It was however observed that poor quality of materials/mixes were used. The project is in use, serving the intended purpose.

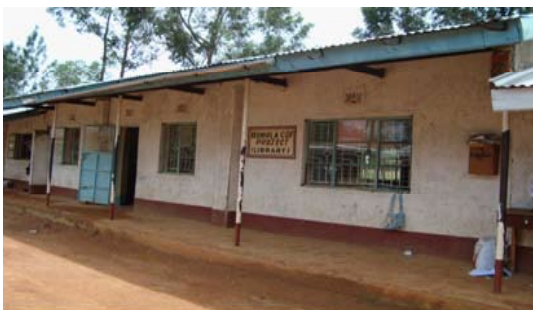
Project Number	CDF/B/012A/2007-08

Constituency	Bumula				
Project Name	Mwiruti Sec School				
Project Activity	Construction library				
Location/Ward	Kabula				
Date of Assessment	06/09/2010				
Total Funds Awarded to Date	500,000				
Total Funds Spent to Date	500,000				
Total Unaccounted Funds	0			Project Category	A
Technical Performance Score	69%			Project Status	Complete and in use
<p><b>Comments:</b> The ceiling board for the library was well fixed and painted. The fascia board was painted with an undercoat only. The verandah could have been done better. There is value for money for the community.</p>

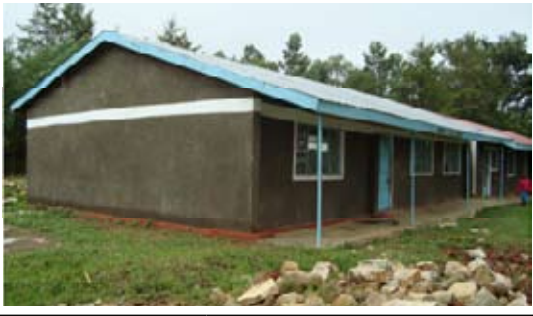
Project Number	CDF/B/013/2007-08

Constituency	Bumula				
Project Name	Kabula Youth Polytechnic				
Project Activity	Workshop construction				
Location/Ward	Kabula				
Date of Assessment	26/2/2010				
Total Funds Awarded to Date	900,000				
Total Funds Spent to Date	900,000				
Total Unaccounted Funds	0			Project Category	A
Technical Performance Score	89%			Project Status	Complete and in use
<p><b>Comments:</b> The windows, doors and support pillars were well fitted, fascia board was fixed and painted. Good workmanship is displayed and there is good value for money. The project was well implemented although an over expenditure sighted.</p>

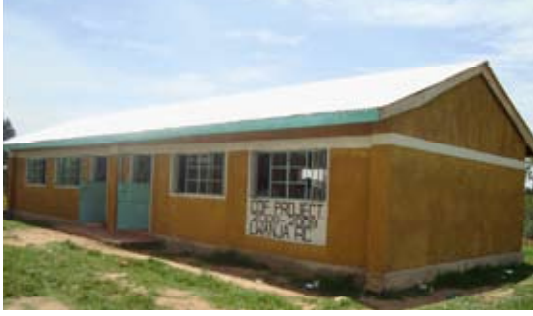
Constituency	Bumula				
Project Name	Lwanja Primary School				
Project Activity	Renovation of 2 Classrooms				
Location/Ward	Kibuke				
Date of Assessment	16/3/2010				
Total Funds Awarded to Date	700,000				
Total Funds Spent to Date	500,000				
Total Unaccounted Funds	200,000			Project Category	A
Technical Performance Score	83%			Project Status	Complete and in use
<p><b>Comments:</b> The funds received in FY 2007/08 for the project were for emergency after heavy rains. The CDF Office never disbursed funds amounting to <b>Kshs.200,000</b> and investigation should be carried out to recover the money. The funds were spent and the project well implemented. The fascia board was well fitted and painted, steel windows were glazed and the rough casting well done. The classrooms have no verandah. <b>See letter in Annex 7.</b></p>

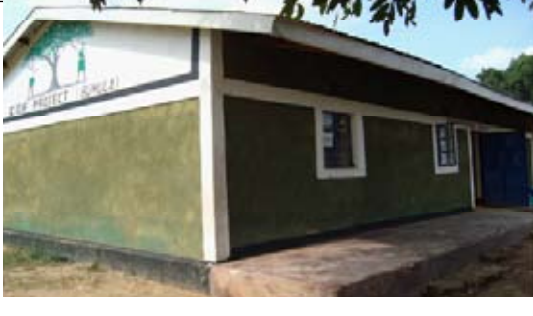
Constituency	Bumula				
Project Name	Namuninge Primary School				
Project Activity	Construction of admin Block				
Location/Ward	Kibuke				
Date of Assessment	13/07/2010				
Total Funds Awarded to Date	600,000				
Total Funds Spent to Date	600,000				
Total Unaccounted Funds	0			Project Category	A
Technical Performance Score	56%			Project Status	Complete and in use
<p><b>Comments:</b> The timber joinings were poorly done. The fascia board was fitted and painted. The rough casting and roofing was well done. The Quality of materials was compromised to bring down the cost. Generally the project reflects value for money allocated.</p>

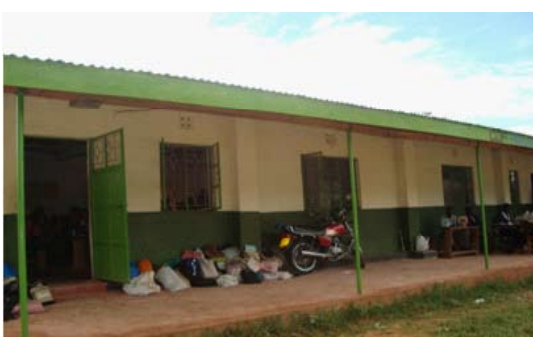
Constituency	Bumula			
Project Name	Tunya Primary School			
Project Activity	Construction of 1 classroom and purchase of land			
Location/Ward	Kibuke			
Date of Assessment	2/3/2010			
Total Funds Awarded to Date	420,000			
Total Funds Spent to Date	420,000			
Total Unaccounted Funds	0		Project Category	A
Technical Performance Score	66%		Project Status	Complete and in use
<b>Comments:</b> The project is complete and in use. The building is well painted. The fascia board is well fitted and painted. The support pillars were erected well. The project cost was within estimates. It reflects good value for money for the taxpayer.

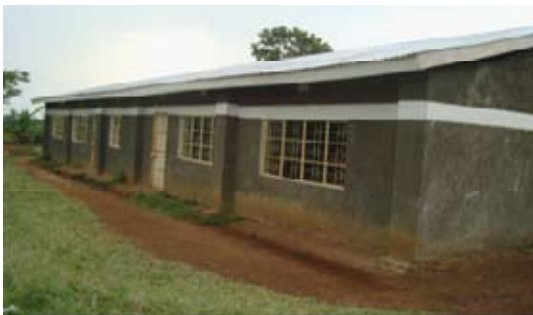
Constituency	Bumula			
Project Name	Machwele Polytechnic			
Project Activity	Construction of 2 rooms			
Location/Ward	Kibuke			
Date of Assessment	16/3/2010			
Total Funds Awarded to Date	900,000			
Total Funds Spent to Date	600,000			
Total Unaccounted Funds	300,000		Project Category	A
Technical Performance Score	65%		Project Status	Complete and in use
<b>Comments:</b> The fascia board was well done and painted. The steel doors and windows were nicely fixed and painted. There is no verandah though and the roof is not supported with pillars. The plinth is low to control running water.

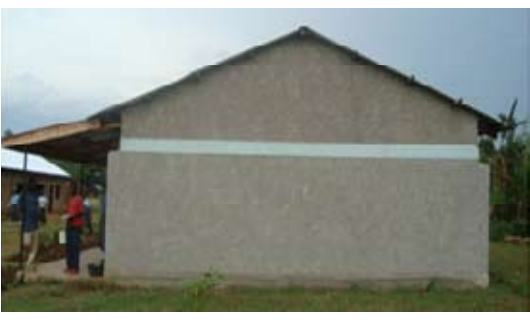
<b>Constituency</b>	Bumula				
<b>Project Name</b>	Muanda Primary School				
<b>Project Activity</b>	Construction of 3 classrooms				
<b>Location/Ward</b>	South Bukusu				
<b>Date of Assessment</b>	23/2/2010				
<b>Total Funds Awarded to Date</b>	500,000				
<b>Total Funds Spent to Date</b>	500,000				
<b>Total Unaccounted Funds</b>	0			<b>Project Category</b>	A
<b>Technical Performance Score</b>	66%			<b>Project Status</b>	Complete and in use
<b>Comments:</b> The classrooms have good support pillars. The rough cast and the painting were well done. Fascia board fitting was not completed and not painted. Glass yet to be fitted on windows. Good workmanship displayed hence good value for money.

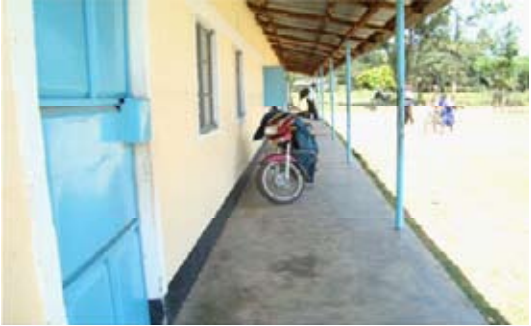
<b>Constituency</b>	Bumula				
<b>Project Name</b>	Miluki RC Primary School				
<b>Project Activity</b>	Construction of 1 classroom and admin block				
<b>Location/Ward</b>	Mukwa.				
<b>Date of Assessment</b>	15/3/2010				
<b>Total Funds Awarded to Date</b>	820,000				
<b>Total Funds Spent to Date</b>	820,000				
<b>Total Unaccounted Funds</b>	0			<b>Project Category</b>	A
<b>Technical Performance Score</b>	67%			<b>Project Status</b>	Complete and in use
<b>Comments:</b> Good quality of materials used. The fascia board was well fitted and painted. The support pillars were nicely erected and painting well done. Steel windows were fixed and glazed. Good value for the taxpayers' money.

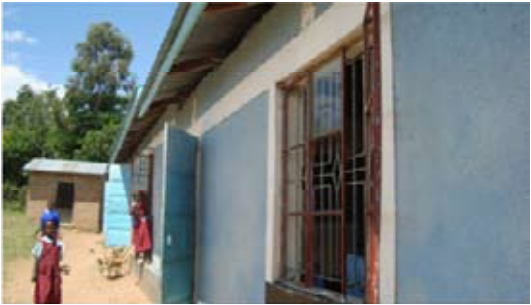
<b>Constituency</b>	Bumula		
<b>Project Name</b>	Bisuche A.C.K. Primary School		
<b>Project Activity</b>	Construction of 3 classrooms		
<b>Location/Ward</b>	Mukwa		
<b>Date of Assessment</b>	3/3/2010		
<b>Total Funds Awarded to Date</b>	700,000		
<b>Total Funds Spent to Date</b>	700,000		
<b>Total Unaccounted Funds</b>	0	<b>Project Category</b>	A
<b>Technical Performance Score</b>	86%	<b>Project Status</b>	Complete and in use

**Comments:** The project was complete at the time of visit. It has a well painted fascia board. Finishing and fittings were well done. Broken window glass need to be replaced. The project cost reflects value for money since it was within the budget.

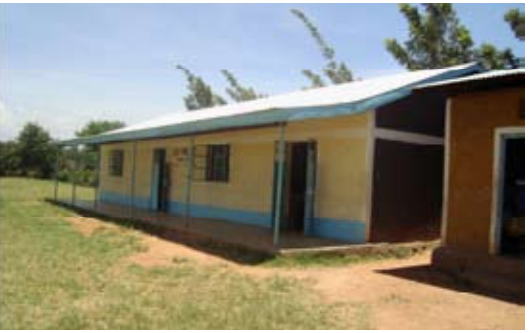
<b>Constituency</b>	Bumula		
<b>Project Name</b>	Kisawayi Primary School		
<b>Project Activity</b>	Construction of 2 classrooms and renovation of 10 classrooms		
<b>Location/Ward</b>	Mukwa		
<b>Date of Assessment</b>	15/3/2010		
<b>Total Funds Awarded to Date</b>	700,000		
<b>Total Funds Spent to Date</b>	700,000		
<b>Total Unaccounted Funds</b>	0	<b>Project Category</b>	A
<b>Technical Performance Score</b>	59%	<b>Project Status</b>	Complete and in use

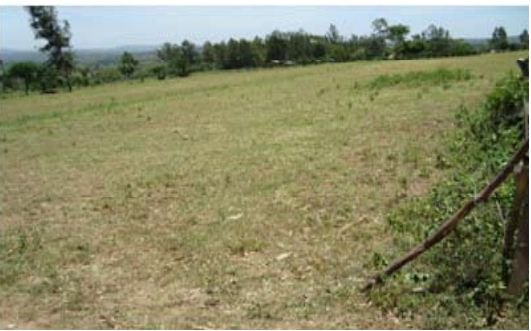
<b>Constituency</b>	Bumula		
<b>Project Name</b>	Manani Primary School		
<b>Project Activity</b>	Purchase of Land and completion of verandah for 3 classrooms		
<b>Location/Ward</b>	Mukwa		
<b>Date of Assessment</b>	15/3/2010		
<b>Total Funds Awarded to Date</b>	820,000		
<b>Total Funds Spent to Date</b>	820,000		
<b>Total Unaccounted Funds</b>	0	<b>Project Category</b>	A
<b>Technical Performance Score</b>	60%	<b>Project Status</b>	Complete and in use

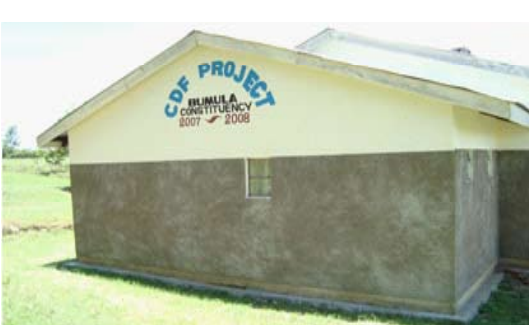
<b>Constituency</b>	Bumula		
<b>Project Name</b>	Miluki Dispensary		
<b>Project Activity</b>	Purchase of Land and Construction of staff house		
<b>Location/Ward</b>	Mukwa		
<b>Date of Assessment</b>	15/3/2010		
<b>Total Funds Awarded to Date</b>	1,700,000		
<b>Total Funds Spent to Date</b>	1,700,000		
<b>Total Unaccounted Funds</b>	0	<b>Project Category</b>	A
<b>Technical Performance Score</b>	54%	<b>Project Status</b>	Complete and in use

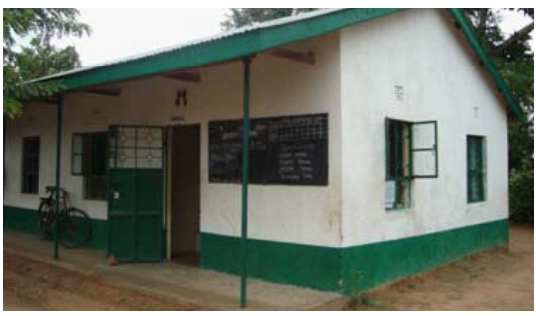
<b>Constituency</b>	Bumula		
<b>Project Name</b>	Khelela A.C.K Primary School		
<b>Project Activity</b>	Construction of a classrooms & office		
<b>Location/Ward</b>	Mabusi		
<b>Date of Assessment</b>	1/3/2010		
<b>Total Funds Awarded to Date</b>	900,000		
<b>Total Funds Spent to Date</b>	900,000		
<b>Total Unaccounted Funds</b>	0		<b>Project Category</b> A
<b>Technical Performance Score</b>	73%		<b>Project Status</b> Complete and in use
<b>Comments:</b> The construction of a classroom and an office was well done. Fascia board was well fitted and painted. Finishing and fittings were well done, good workmanship displayed and hence good value for the taxpayers' money.

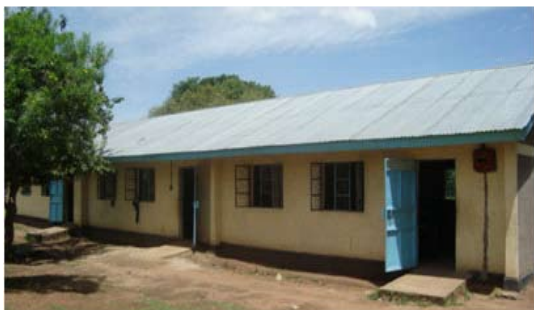
<b>Constituency</b>	Bumula		
<b>Project Name</b>	Chiliba A.C.K Primary School		
<b>Project Activity</b>	Construction of 3 classrooms		
<b>Location/Ward</b>	Mabusi		
<b>Date of Assessment</b>	24/2/2010		
<b>Total Funds Awarded to Date</b>	500,000		
<b>Total Funds Spent to Date</b>	500,000		
<b>Total Unaccounted Funds</b>	0		<b>Project Category</b> A
<b>Technical Performance Score</b>	59%		<b>Project Status</b> Complete and in use
<b>Comments:</b> The project was completed well. The fascia board is painted and fittings well done. The roofing was good and strong timber used in erecting it. Good workmanship was displayed hence good value for money to the benefit of the community.

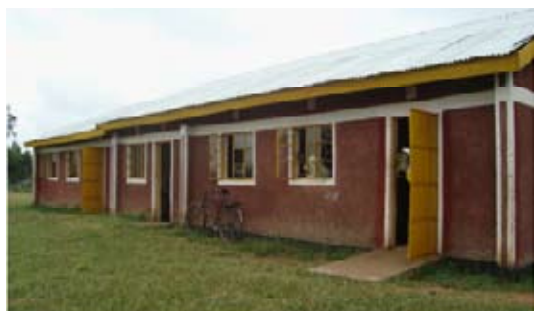
<b>Constituency</b>	Bumula		
<b>Project Name</b>	St. Peters Namaika School		
<b>Project Activity</b>	Construction of 1 classroom & 1 office		
<b>Location/Ward</b>	Mabusi		
<b>Date of Assessment</b>	1/3/2010		
<b>Total Funds Awarded to Date</b>	700,000		
<b>Total Funds Spent to Date</b>	700,000		
<b>Total Unaccounted Funds</b>	0		<b>Project Category</b> A
<b>Technical Performance Score</b>	63%		<b>Project Status</b> Complete and in use
<b>Comments:</b> This project is in use. The painting and rough casting was well done, fascia board was properly fixed and painted. Steel windows and doors were well fitted and glazed. Timber was not used for roofing instead untreated rafters were used. The project cost was within the estimated budget.

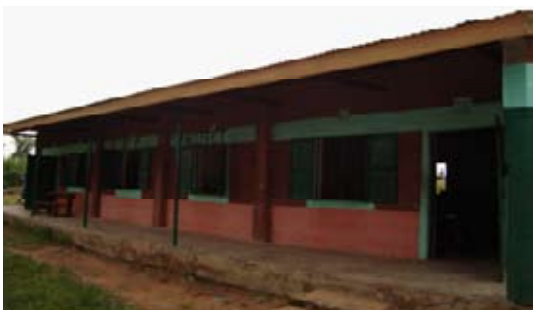
<b>Constituency</b>	Bumula		
<b>Project Name</b>	Kimatuni S.A Primary School		
<b>Project Activity</b>	Construction of 2 classrooms		
<b>Location/Ward</b>	Mabusi		
<b>Date of Assessment</b>	13/07/2010		
<b>Total Funds Awarded to Date</b>	500,000		
<b>Total Funds Spent to Date</b>	500,000		
<b>Total Unaccounted Funds</b>	0		<b>Project Category</b> A
<b>Technical Performance Score</b>	76%		<b>Project Status</b> Complete and in use
<b>Comments:</b> The verandah was well constructed with support pillars. The fascia board fitted well and painted. Rough cast was well done and the roof erected with treated timber and gal sheet. There is a clear indication of good value for money and the project is serving the community.

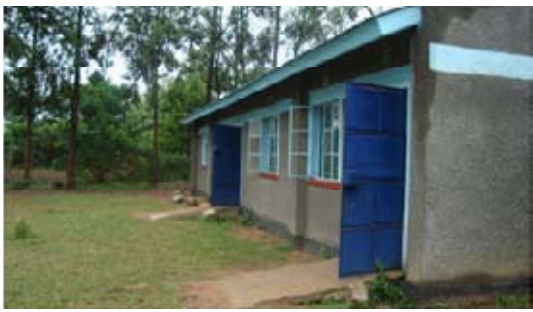
<b>Constituency</b>	Bumula		
<b>Project Name</b>	Sikinga F.Y.M Primary School		
<b>Project Activity</b>	Construction of 2 classrooms		
<b>Location/Ward</b>	Mabusi		
<b>Date of Assessment</b>	1/3/2010		
<b>Total Funds Awarded to Date</b>	500,000		
<b>Total Funds Spent to Date</b>	500,000		
<b>Total Unaccounted Funds</b>	0		<b>Project Category</b> A
<b>Technical Performance Score</b>	81%		<b>Project Status</b> Complete and in use
<b>Comments:</b> Walls and fascia board were well painted, roofing timber treated and the doors and windows nicely fitted. The window panes are fitted with glass. However the classrooms have no verandah and support pillars. There is value for money for the community in the project.

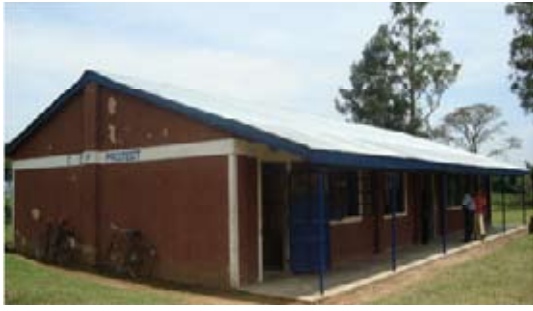
<b>Constituency</b>	Bumula		
<b>Project Name</b>	Masuno R.C. Primary School		
<b>Project Activity</b>	Construction of 2 classrooms		
<b>Location/Ward</b>	Mabusi		
<b>Date of Assessment</b>	25/2/2010		
<b>Total Funds Awarded to Date</b>	800,000		
<b>Total Funds Spent to Date</b>	800,000		
<b>Total Unaccounted Funds</b>	0		<b>Project Category</b> A
<b>Technical Performance Score</b>	83%		<b>Project Status</b> Complete and in use
<b>Comments:</b> In constructing the classrooms the support pillars were well erected and the fascia board well fitted and fully painted. In addition steel doors and windows were fitted. However the roofing timber was not treated. This is a well implemented project that is in use therefore value for taxpayers' money.

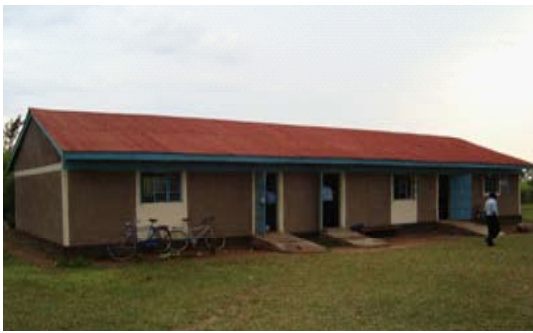
<b>Constituency</b>	Bumula		
<b>Project Name</b>	Lunao R.C Primary School		
<b>Project Activity</b>	Construction of 2 Classrooms & renovation of 1 office and 7 classrooms		
<b>Location/Ward</b>	Bumula		
<b>Date of Assessment</b>	24/02/2010		
<b>Total Funds Awarded to Date</b>	600,000		
<b>Total Funds Spent to Date</b>	600,000		
<b>Total Unaccounted Funds</b>	0		<b>Project Category</b> A
<b>Technical Performance Score</b>	75%		<b>Project Status</b> Complete and in use
<b>Comments:</b> Good workmanship was employed in implementing the project. The roofing and fascia board were well done. Steel windows and doors were also well fitted and glazed. The painting was nicely done. The project is good value for money.

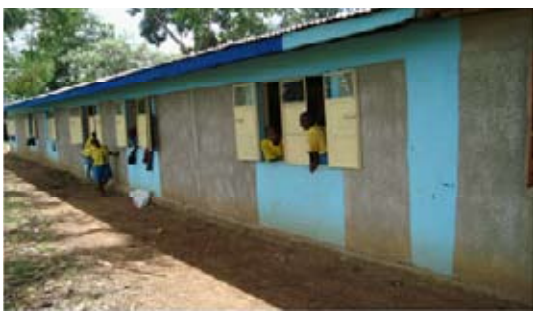
<b>Constituency</b>	Bumula		
<b>Project Name</b>	Bunambobi Primary School		
<b>Project Activity</b>	Construction of 3 classrooms		
<b>Location/Ward</b>	Bumula		
<b>Date of Assessment</b>	24/2/2010		
<b>Total Funds Awarded to Date</b>	620,000		
<b>Total Funds Spent to Date</b>	620,000		
<b>Total Unaccounted Funds</b>	0		<b>Project Category</b> A
<b>Technical Performance Score</b>	66%		<b>Project Status</b> Complete and in use
<b>Comments:</b> For these classrooms the steel windows and doors were nicely fitted. Fascia board was fitted well and painted. The support pillars have good diameter and the verandah is also well done. Generally good value for money for the community.

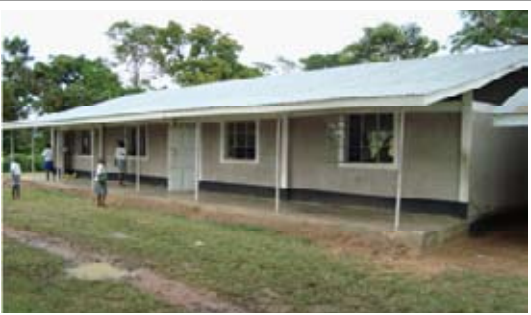
<b>Constituency</b>	Bumula		
<b>Project Name</b>	Mungore primary School		
<b>Project Activity</b>	Construction of 2 Classrooms		
<b>Location/Ward</b>	Khasoko		
<b>Date of Assessment</b>	1/3/2010		
<b>Total Funds Awarded to Date</b>	600,000		
<b>Total Funds Spent to Date</b>	600,000		
<b>Total Unaccounted Funds</b>	0		<b>Project Category</b> A
<b>Technical Performance Score</b>	83%		<b>Project Status</b> Complete and in use
<b>Comments:</b> Well implemented with good quality materials used. The support pillars were well erected and the painting well done. The Fascia board was properly fixed. The doors and windows were also nicely fitted. This project is definitely good value for the taxpayer's money. Good workmanship was displayed. Kshs.100,000 from LATF was also used on the project.

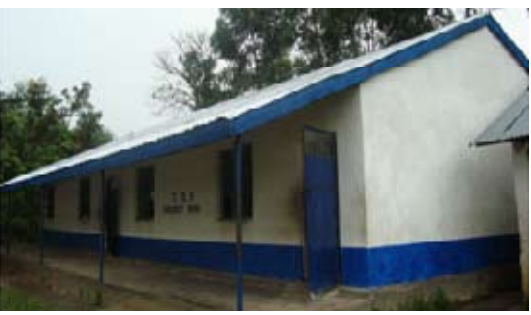
<b>Constituency</b>	Bumula		
<b>Project Name</b>	Namanje R.C Primary School		
<b>Project Activity</b>	Construction of 2 Classrooms		
<b>Location/Ward</b>	Khasoko		
<b>Date of Assessment</b>	26/2/2010		
<b>Total Funds Awarded to Date</b>	900,000		
<b>Total Funds Spent to Date</b>	900,000		
<b>Total Unaccounted Funds</b>	0		<b>Project Category</b> A
<b>Technical Performance Score</b>	66%		<b>Project Status</b> Complete and in use
<b>Comments:</b> The project was completed, painting well done and support pillars properly erected. The fascia board was well fitted and painted. The steel windows and doors are well fitted and glazed. Good workmanship is displayed in the work done.

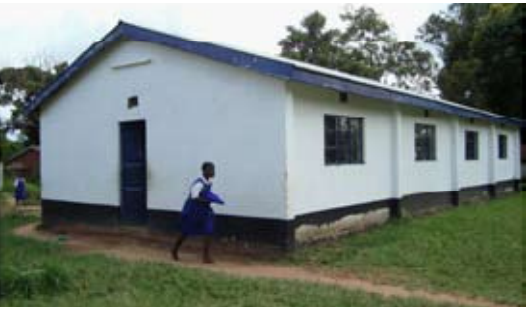
<b>Constituency</b>	Bumula		
<b>Project Name</b>	Khasoko Primary School		
<b>Project Activity</b>	Construction of a dormitory		
<b>Location/Ward</b>	Khasoko.		
<b>Date of Assessment</b>	1/3/2010-1434h		
<b>Total Funds Awarded to Date</b>	700,000		
<b>Total Funds Spent to Date</b>	700,000		
<b>Total Unaccounted Funds</b>	0		<b>Project Category</b> A
<b>Technical Performance Score</b>	89%		<b>Project Status</b> Complete and in use
<b>Comments:</b> The project was well implemented. The fascia board was nicely fixed. The doors and windows are made of steel and properly fitted. Painting was poorly done. Unfortunately there are no beds forcing children to sleep on the floor.

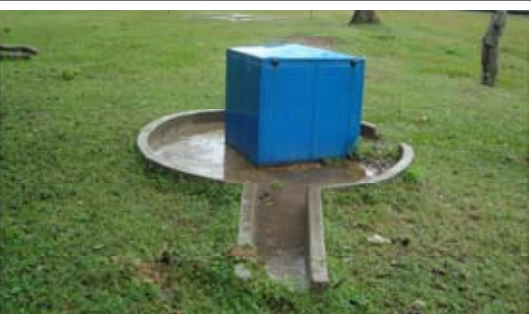
<b>Constituency</b>	Bumula		
<b>Project Name</b>	Khasoko Secondary School		
<b>Project Activity</b>	Drilling of borehole		
<b>Location/Ward</b>	Khasoko		
<b>Date of Assessment</b>	26/2/2010		
<b>Total Funds Awarded to Date</b>	500,000		
<b>Total Funds Spent to Date</b>	500,000		
<b>Total Unaccounted Funds</b>	0		<b>Project Category</b> A
<b>Technical Performance Score</b>	89%		<b>Project Status</b> Complete and in use
<b>Comments:</b> The borehole was drilled and is in use. There is fair workmanship though the materials used would have been better. However the cost corresponds to the value of the work done.

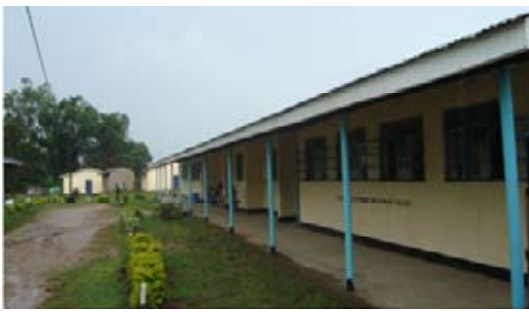
<b>Constituency</b>	Bumula		
<b>Project Name</b>	Khasoko secondary School		
<b>Project Activity</b>	Construction of 2 classrooms		
<b>Location/Ward</b>	Khasoko		
<b>Date of Assessment</b>	26/02/2010		
<b>Total Funds Awarded to Date</b>	850,000		
<b>Total Funds Spent to Date</b>	850,000		
<b>Total Unaccounted Funds</b>	0		<b>Project Category</b> A
<b>Technical Performance Score</b>	63%		<b>Project Status</b> Complete and in use

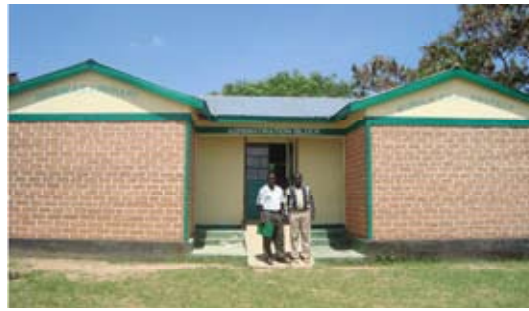
<b>Constituency</b>	Bumula		
<b>Project Name</b>	Nandika Primary School		
<b>Project Activity</b>	Construction of administration block		
<b>Location/Ward</b>	Siboti		
<b>Date of Assessment</b>	10/3/2010		
<b>Total Funds Awarded to Date</b>	620,000		
<b>Total Funds Spent to Date</b>	620,000		
<b>Total Unaccounted Funds</b>	0		<b>Project Category</b> A
<b>Technical Performance Score</b>	89%		<b>Project Status</b> Complete and in use

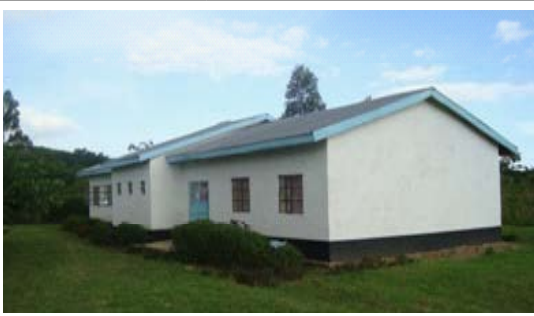
<b>Constituency</b>	Bumula				
<b>Project Name</b>	Siboti Dispensary				
<b>Project Activity</b>	Staff house and female ward				
<b>Location/Ward</b>	Siboti				
<b>Date of Assessment</b>	12/07/2010				
<b>Total Funds Awarded to Date</b>	1,600,000.				
<b>Total Funds Spent to Date</b>	1,600,000.				
<b>Total Unaccounted Funds</b>	0			<b>Project Category</b>	A
<b>Technical Performance Score</b>	74%			<b>Project Status</b>	Complete and in use
<p><b>Comments:</b> The project is complete and in use with fairly good workmanship displayed in the wards and outpatient department. Estimates and expenditure were within the budget. Fascia board was well fitted and painted. There is value for money for the community.</p>

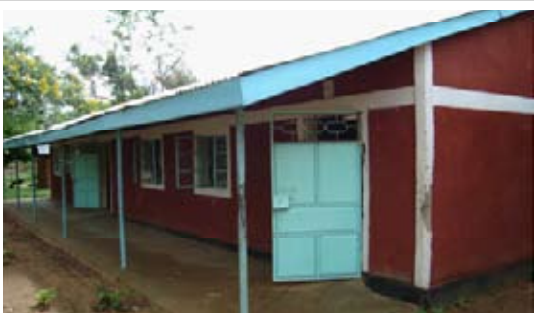
<b>Constituency</b>	Bumula				
<b>Project Name</b>	Bitobo RC Primary School				
<b>Project Activity</b>	Construction of 2 classrooms				
<b>Location/Ward</b>	Napara				
<b>Date of Assessment</b>	1/3/2010				
<b>Total Funds Awarded to Date</b>	620,000				
<b>Total Funds Spent to Date</b>	620,000				
<b>Total Unaccounted Funds</b>	0			<b>Project Category</b>	A
<b>Technical Performance Score</b>	69%			<b>Project Status</b>	Complete and in use
<p><b>Comments:</b> The project was well implemented, steel windows and doors were fixed and glazed. Fascia board was nicely fitted and painted. The support pillars were well erected. There is good value for money for the taxpayer.</p>

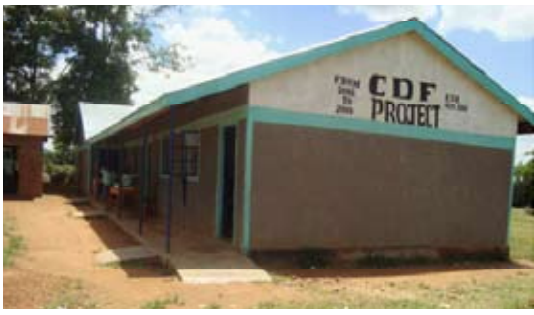
<b>Constituency</b>	Bumula				
<b>Project Name</b>	Nakalila Primary School				
<b>Project Activity</b>	Construction of 3 classrooms				
<b>Location/Ward</b>	Napara				
<b>Date of Assessment</b>	03/03/2010				
<b>Total Funds Awarded to Date</b>	620,000				
<b>Total Funds Spent to Date</b>	620,000				
<b>Total Unaccounted Funds</b>	0			<b>Project Category</b>	A
<b>Technical Performance Score</b>	76%			<b>Project Status</b>	Complete and in use
<p><b>Comments:</b> Verandah was well done with good support pillars. Fascia board and walls were nicely painted. Steel doors and windows were fitted well and painted. The classrooms have fairly good finishes done with a walkway and ramps.</p>

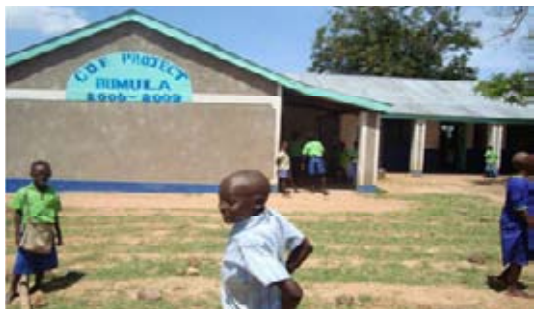
<b>Constituency</b>	Bumula				
<b>Project Name</b>	Masielo Primary School				
<b>Project Activity</b>	Construction of 2 classrooms and Admin Block				
<b>Location/Ward</b>	Napara				
<b>Date of Assessment</b>	9/3/2010				
<b>Total Funds Awarded to Date</b>	920,000				
<b>Total Funds Spent to Date</b>	920,000				
<b>Total Unaccounted Funds</b>	0			<b>Project Category</b>	A
<b>Technical Performance Score</b>	62%			<b>Project Status</b>	Complete and in use
<p><b>Comments:</b> The projects are complete and in use. There is good column support. The fascia board was fitted and painted well. However poor mixing ratio was noticed on some sections of the floor.</p>

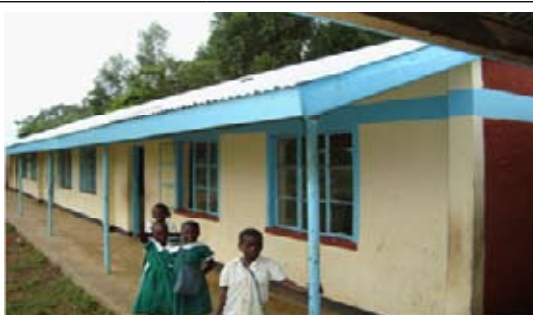
<b>Constituency</b>	Bumula				
<b>Project Name</b>	Lelekwe Primary School				
<b>Project Activity</b>	Construction of 3 classrooms				
<b>Location/Ward</b>	Kimaeti				
<b>Date of Assessment</b>	01/03/2010				
<b>Total Funds Awarded to Date</b>	620,000				
<b>Total Funds Spent to Date</b>	620,000				
<b>Total Unaccounted Funds</b>	0			<b>Project Category</b>	A
<b>Technical Performance Score</b>	89%			<b>Project Status</b>	Complete and in use
<b>Comments:</b> There is excellent workmanship in executing the project. Steel windows and doors were fixed and glazed. The fascia board was nicely fitted and painted. The support pillars are well erected and good value for money for the community.

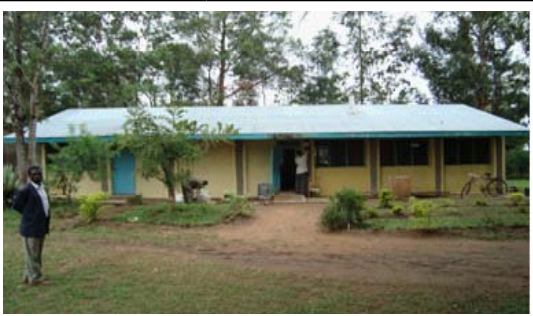
<b>Constituency</b>	Bumula				
<b>Project Name</b>	Myanga Secondary School				
<b>Project Activity</b>	Construction completion of laboratory				
<b>Location/Ward</b>	Kimaeti				
<b>Date of Assessment</b>	12/07/2010				
<b>Total Funds Awarded to Date</b>	800,000				
<b>Total Funds Spent to Date</b>	600,000				
<b>Total Unaccounted Funds</b>	200,000			<b>Project Category</b>	A
<b>Technical Performance Score</b>	76%			<b>Project Status</b>	Complete and in use
<b>Comments:</b> The project received funding from CDF when it was on wall plate. The project did not receive Kshs.200,000 in F/Y 2006/07 CDF allocation. The louver windows were nicely fixed, the roofing was well done with treated timber. There is a painted fascia board and the drawers are lockable. There is value for taxpayers' money

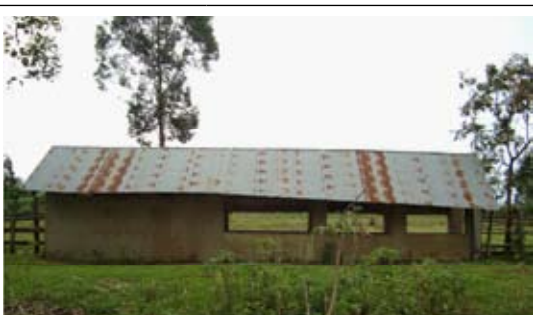
<b>Constituency</b>	Bumula				
<b>Project Name</b>	Nandingwa Cattle Dip				
<b>Project Activity</b>	Construction of Cattle Dip				
<b>Location/Ward</b>	Bumula				
<b>Date of Assessment</b>	26/02/2010				
<b>Total Funds Awarded to Date</b>	50,000				
<b>Total Funds Spent to Date</b>	50,000				
<b>Total Unaccounted Funds</b>	0			<b>Project Category</b>	A
<b>Technical Performance Score</b>	69%			<b>Project Status</b>	Complete and in use
<b>Comments:</b> The renovation was done using the 30G iron sheets. Part of the money amounting to Kshs.25,000 was paid to the land owner. The project was well implemented and is within the stipulated budget. Good value for money.

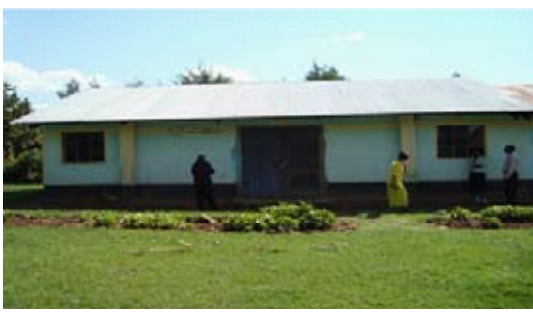
<b>Constituency</b>	Bumula		
<b>Project Name</b>	ST. Teresa's Kabula Sec School		
<b>Project Activity</b>	Dormitory Construction		
<b>Location/Ward</b>	Kabula		
<b>Date of Assessment</b>	16/07/2010		
<b>Total Funds Awarded to Date</b>	800,000		
<b>Total Funds Spent to Date</b>	800,000		
<b>Total Unaccounted Funds</b>	0		<b>Project Category</b> B
<b>Technical Performance Score</b>	49%		<b>Project Status</b> Complete and in use

**Comments:** The project was poorly done. Old wooden doors were fitted. Water based paint was used and it has been washed off already. There is no fascia board fitted and roofing timber was not properly treated. There are visible cracks on the walls. The project is of low value given the funds spent.

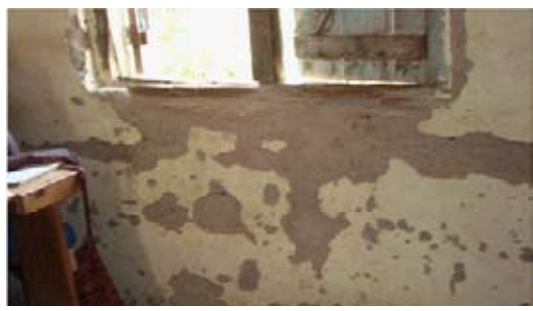
<b>Constituency</b>	Bumula		
<b>Project Name</b>	Kimatuni R.C Primary School		
<b>Project Activity</b>	Renovation of 4 classroom		
<b>Location/Ward</b>	South Bukusu		
<b>Date of Assessment</b>	24/2/2010		
<b>Total Funds Awarded to Date</b>	500,000		
<b>Total Funds Spent to Date</b>	500,000		
<b>Total Unaccounted Funds</b>	0		<b>Project Category</b> B
<b>Technical Performance Score</b>	43%		<b>Project Status</b> Complete and in use

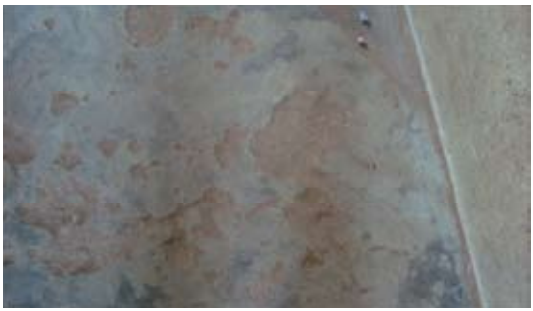
<b>Constituency</b>	Bumula		
<b>Project Name</b>	Tabuti/Sudi Primary School		
<b>Project Activity</b>	Construction of 4 classrooms		
<b>Location/Ward</b>	South Bukusu		
<b>Date of Assessment</b>	24/2/2010		
<b>Total Funds Awarded to Date</b>	700,000		
<b>Total Funds Spent to Date</b>	700,000		
<b>Total Unaccounted Funds</b>	0		<b>Project Category</b> B
<b>Technical Performance Score</b>	47%		<b>Project Status</b> Complete and in use

**Comments:** Doors, windows, fascia board and roofing were well done. Low quality materials were used on the floor. There are ugly cracks and patches. As a result the floor is very dusty. Workmanship employed was not good hence no value for money for the community.

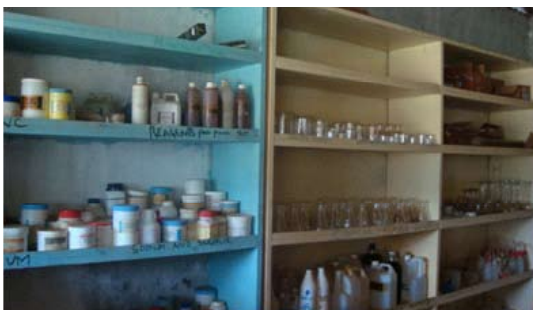
<b>Constituency</b>	Bumula		
<b>Project Name</b>	Mareka Secondary School		
<b>Project Activity</b>	Purchase of laboratory equipment		
<b>Location/Ward</b>	South Bukusu		
<b>Date of Assessment</b>	23/2/2010		
<b>Total Funds Awarded to Date</b>	800,000		
<b>Total Funds Spent to Date</b>	800,000		
<b>Total Unaccounted Funds</b>	0		<b>Project Category</b> B
<b>Technical Performance Score</b>	48%		<b>Project Status</b> Complete and in use

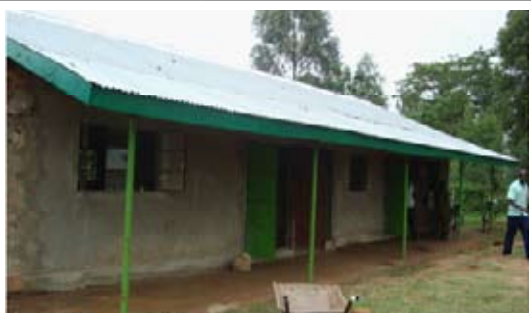
<b>Constituency</b>	Bumula		
<b>Project Name</b>	Khelela Youth Polytechnic		
<b>Project Activity</b>	Construction of 2 classrooms & 1 office		
<b>Location/Ward</b>	Mabusi		
<b>Date of Assessment</b>	1/3/2010		
<b>Total Funds Awarded to Date</b>	900,000		
<b>Total Funds Spent to Date</b>	900,000		
<b>Total Unaccounted Funds</b>	0		<b>Project Category</b> B
<b>Technical Performance Score</b>	46%		<b>Project Status</b> Ongoing and in use
<b>Comments:</b> The finishing for this project was poor. The plastering and painting was poorly done. There is clear indication that poor quality materials were used. The windows and doors fitting was also poorly done. There is no good workmanship displayed.

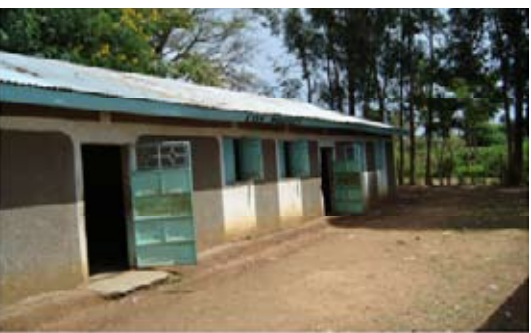
<b>Constituency</b>	Bumula		
<b>Project Name</b>	Lunao FYM Primary School		
<b>Project Activity</b>	Construction of 5 classrooms & 1 office		
<b>Location/Ward</b>	Bumula		
<b>Date of Assessment</b>	24/3/20210		
<b>Total Funds Awarded to Date</b>	820,000		
<b>Total Funds Spent to Date</b>	820,000		
<b>Total Unaccounted Funds</b>	0		<b>Project Category</b> B
<b>Technical Performance Score</b>	33%		<b>Project Status</b> Ongoing and in use
<b>Comments:</b> In constructing the classrooms and office poor quality of materials was used. Rusting was evident on the roofing iron sheets. Wooden windows were used. Some of the classrooms have no windows. The building has no verandah nor supporting pillars.

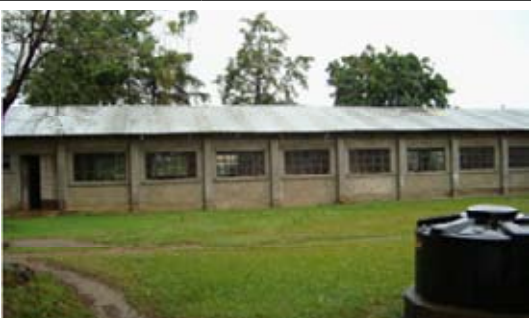
<b>Constituency</b>	Bumula		
<b>Project Name</b>	Bumula Health Centre		
<b>Project Activity</b>	Completion of wards		
<b>Location/Ward</b>	Bumula		
<b>Date of Assessment</b>	26/2/2010		
<b>Total Funds Awarded to Date</b>	1,100,000		
<b>Total Funds Spent to Date</b>	1,100,000		
<b>Total Unaccounted Funds</b>	0		<b>Project Category</b> B
<b>Technical Performance Score</b>	45%		<b>Project Status</b> Ongoing and not in use
<b>Comments:</b> The initial project was drilling of borehole and purchase of solar panel. The CDF diverged funds to completion of Wards after awarding Ksh.400,000 to the project when it had cost the Ministry of Health Ksh.2,900,000. The project as it is has consumed Kshs.4,000,000 of Taxpayers money. It was poorly implemented with poor quality of materials like iron sheets used which are already rusting even before the community starts utilising the facility.. The amount spent is way above what was needed to complete the project. Further investigations is recommended to recover taxpayers money.

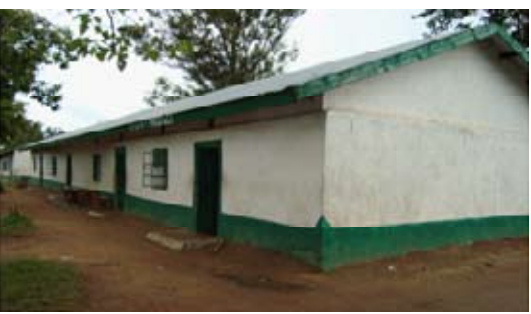
<b>Constituency</b>	Bumula		
<b>Project Name</b>	Namatotoa Primary School		
<b>Project Activity</b>	Renovation of 4 classrooms		
<b>Location/Ward</b>	Khasoko.		
<b>Date of Assessment</b>	1/3/2010		
<b>Total Funds Awarded to Date</b>	620,000		
<b>Total Funds Spent to Date</b>	620,000		
<b>Total Unaccounted Funds</b>	0		<b>Project Category</b> B
<b>Technical Performance Score</b>	49%		<b>Project Status</b> Complete and in use
<b>Comments:</b> Initially the activity was construction of 2 classrooms but they opted for renovations. The painting was poorly done on the wall and fascia board. There is no verandah and support pillars. The roofing timbers are not treated.

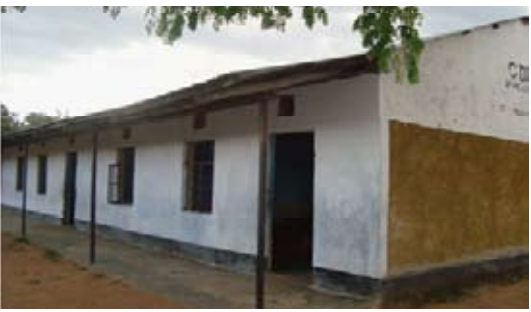
<b>Constituency</b>	Bumula				
<b>Project Name</b>	Bosio Primary School				
<b>Project Activity</b>	Construction of 3 classrooms				
<b>Location/Ward</b>	Siboti				
<b>Date of Assessment</b>	13/03/2010				
<b>Total Funds Awarded to Date</b>	700,000				
<b>Total Funds Spent to Date</b>	700,000				
<b>Total Unaccounted Funds</b>	0			<b>Project Category</b>	B
<b>Technical Performance Score</b>	46%			<b>Project Status</b>	Ongoing and in use
<b>Comments:</b> Poor quality materials were used for construction of the classrooms. The doors are already broken and there are cracks and holes on the floor. There is no fascia board fitted while the roofing was done with untreated poles. There is no value for the taxpayer in this case.

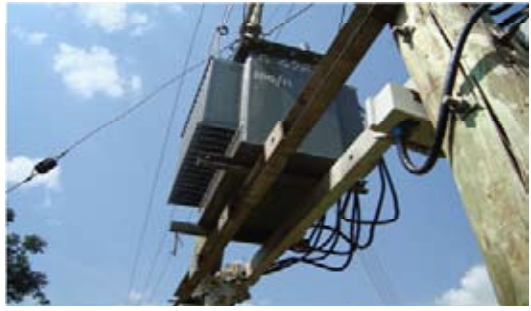
<b>Constituency</b>	Bumula				
<b>Project Name</b>	Musakasa electrification				
<b>Project Activity</b>	Power Supply				
<b>Location/Ward</b>	Napara				
<b>Date of Assessment</b>	12/07/2010				
<b>Total Funds Awarded to Date</b>	639,846				
<b>Total Funds Spent to Date</b>	639,846				
<b>Total Unaccounted Funds</b>	0			<b>Project Category</b>	B
<b>Technical Performance Score</b>	30%			<b>Project Status</b>	Complete and not in use
<b>Comments:</b> The community was not involved in the selection and implementation of the project. At the moment the power is not serving the majority of the community members. The community is not aware that it is a CDF project.

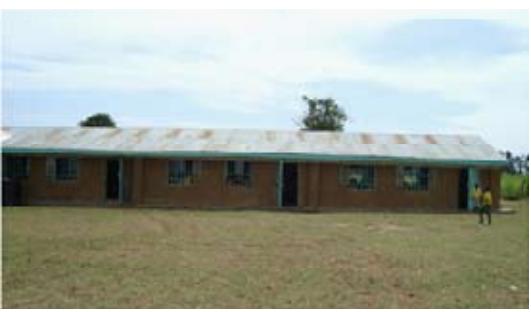
**Comments:** Painting was well done and fascia board nicely fixed and painted. Steel doors and windows were well fitted. Although low quality iron sheet were used as evidenced by the rusting.

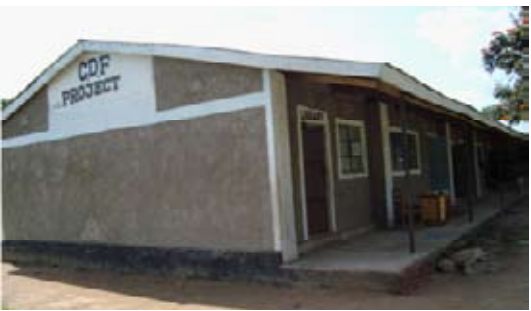
**Comments:** One of the classrooms is being used as a library. The verandah was well done. Noticeably the fascia board had cracks and the roofing poles used were not treated. The walls also have several visible cracks and the ventilators were not completed at the time of assessment.

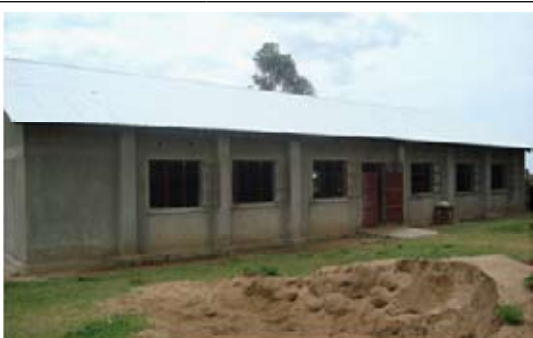
**Comments:** The project involves construction of a dining hall but is yet to be completed. No glass have been fitted on the windows and the fascia board and painting yet to be done. Plaster work was incomplete. Good workmanship as observed on the plaster and roof.
