# Citizen's Constituency Development Fund Report Card for Bumula Constituency Bungoma County

- This Citizen's Report Card presents findings from research in Bumula Constituency. The report covers one government Financial Year 2007/08. The NTA has not researched the 2008/09 Financial Year as much of the funds have not been spent to date.

Project Classification Summary Tables,  
Project Profiles and digital photographs  
for all CDF projects visited and assessed in  
the Financial Year (FY) 2007 - 08

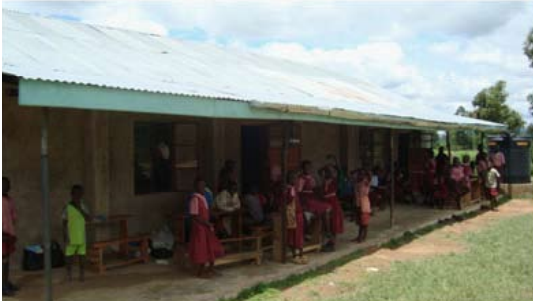
Project Number	CDF/B/021/2007-08

Constituency	Bumula			
Project Name	Tunya Primary School			
Project Activity	Construction of 1 classroom and purchase of land			
Location/Ward	Kibuke			
Date of Assessment	2/3/2010			
Total Funds Awarded to Date	420,000			
Total Funds Spent to Date	420,000			
Total Unaccounted Funds	0		Project Category	A
Technical Performance Score	66%		Project Status	Complete and in use
<b>Comments:</b> The project is complete and in use. The building is well painted. The fascia board is well fitted and painted. The support pillars were erected well. The project cost was within estimates. It reflects good value for money for the taxpayer.

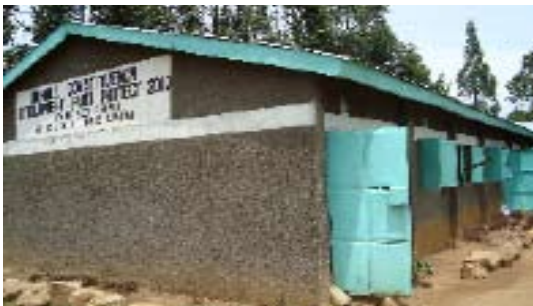
Project Number	CDF/B/027/2007-08

Constituency	Bumula			
Project Name	Machwele Polytechnic			
Project Activity	Construction of 2 rooms			
Location/Ward	Kibuke			
Date of Assessment	16/3/2010			
Total Funds Awarded to Date	900,000			
Total Funds Spent to Date	600,000			
Total Unaccounted Funds	300,000		Project Category	A
Technical Performance Score	65%		Project Status	Complete and in use
<b>Comments:</b> The fascia board was well done and painted. The steel doors and windows were nicely fixed and painted. There is no verandah though and the roof is not supported with pillars. The plinth is low to control running water.

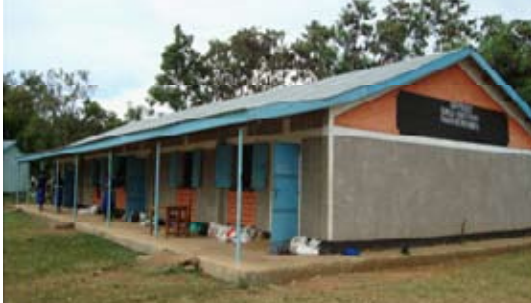
<b>Project Number</b>	CDF/B/030/2007-08

<b>Constituency</b>	Bumula				
<b>Project Name</b>	Muanda Primary School				
<b>Project Activity</b>	Construction of 3 classrooms				
<b>Location/Ward</b>	South Bukusu				
<b>Date of Assessment</b>	23/2/2010				
<b>Total Funds Awarded to Date</b>	500,000				
<b>Total Funds Spent to Date</b>	500,000				
<b>Total Unaccounted Funds</b>	0			<b>Project Category</b>	A
<b>Technical Performance Score</b>	66%			<b>Project Status</b>	Complete and in use
<b>Comments:</b> The classrooms have good support pillars. The rough cast and the painting were well done. Fascia board fitting was not completed and not painted. Glass yet to be fitted on windows. Good workmanship displayed hence good value for money.

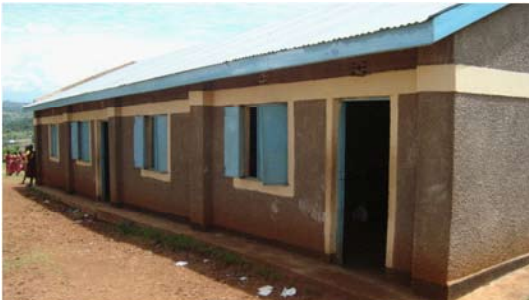
<b>Project Number</b>	CDF/B/032/2007-08

<b>Constituency</b>	Bumula				
<b>Project Name</b>	Lumboka R.C Primary School				
<b>Project Activity</b>	Construction of 2 Classrooms & Admin block				
<b>Location/Ward</b>	South Bukusu				
<b>Date of Assessment</b>	23/2/2007				
<b>Total Funds Awarded to Date</b>	650,000				
<b>Total Funds Spent to Date</b>	650,000				
<b>Total Unaccounted Funds</b>	0			<b>Project Category</b>	A
<b>Technical Performance Score</b>	83%			<b>Project Status</b>	Complete and in use
<b>Comments:</b> In this project the painting on the walls and the rough casting were well done. The support pillars were well erected. However the floor has cracks hence implying lack of good workmanship on that area. We can conclude that despite the floor the project was well implemented hence fair value for money.

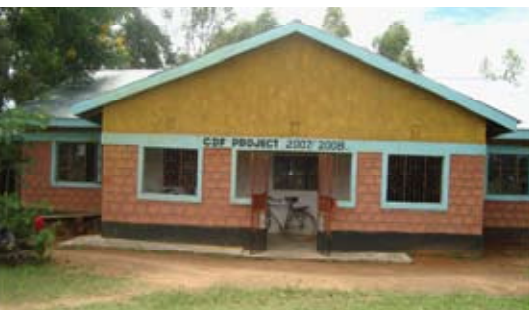
<b>Project Number</b>	CDF/B/081A/2007/08

**Comments:** Good workmanship is displayed on the project. The fascia board was well painted and the walls nicely done. Steel windows and door were well fitted. Good value for the money.

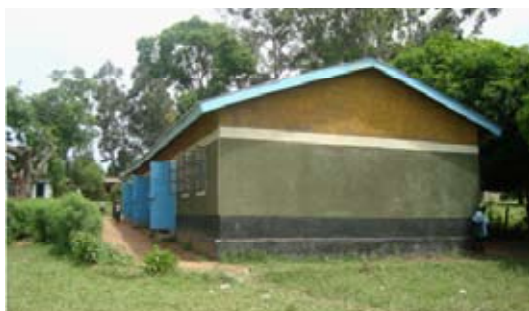
<b>Project Number</b>	CDF/B/081B/2007/08

<b>Constituency</b>	Bumula		
<b>Project Name</b>	Musakasa Primary School		
<b>Project Activity</b>	Construction of Admin Block		
<b>Location/Ward</b>	Siboti		
<b>Date of Assessment</b>	04/03/2010		
<b>Total Funds Awarded to Date</b>	600,000		
<b>Total Funds Spent to Date</b>	600,000		
<b>Total Unaccounted Funds</b>	0		<b>Project Category</b> A
<b>Technical Performance Score</b>	75%		<b>Project Status</b> Complete and in use

**Comments:** Workmanship displayed was good. The fascia board and painting were nicely done. Steel windows and doors are well fitted. This project was entirely funded by CDF. The administration block is good value for money and serves the community.

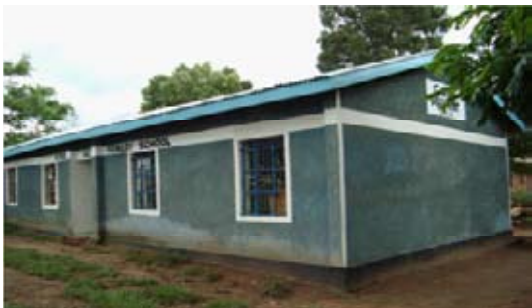
<b>Project Number</b>	CDF/B/091/2007-08

<b>Constituency</b>	Bumula				
<b>Project Name</b>	Masielo Primary School				
<b>Project Activity</b>	Construction of 2 classrooms and Admin Block				
<b>Location/Ward</b>	Napara				
<b>Date of Assessment</b>	9/3/2010				
<b>Total Funds Awarded to Date</b>	920,000				
<b>Total Funds Spent to Date</b>	920,000				
<b>Total Unaccounted Funds</b>	0			<b>Project Category</b>	A
<b>Technical Performance Score</b>	62%			<b>Project Status</b>	Complete and in use
<p><b>Comments:</b> The projects are complete and in use. There is good column support. The fascia board was fitted and painted well. However poor mixing ratio was noticed on some sections of the floor.</p>

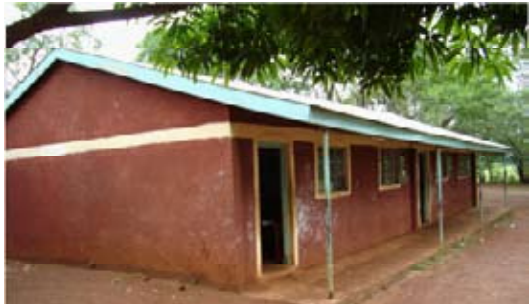
<b>Project Number</b>	CDF/B/097/2007-08

<b>Constituency</b>	Bumula		
<b>Project Name</b>	Kitabisi RC Primary School		
<b>Project Activity</b>	Construction of 1 classroom and administration block		
<b>Location/Ward</b>	Napara		
<b>Date of Assessment</b>	1/3/2010		
<b>Total Funds Awarded to Date</b>	500,000		
<b>Total Funds Spent to Date</b>	500,000		
<b>Total Unaccounted Funds</b>	0		<b>Project Category</b> A
<b>Technical Performance Score</b>	76%		<b>Project Status</b> Complete and in use
<b>Comments:</b> The project was well implemented with fascia board well fixed and painted. The steel windows were fitted and glazed. Quality materials were used for construction.

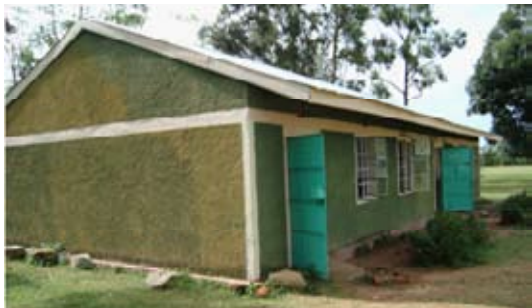
<b>Project Number</b>	CDF/B/098/2007-08

<b>Constituency</b>	Bumula		
<b>Project Name</b>	Tulukuyi Primary School.		
<b>Project Activity</b>	Construction of 2 Classrooms		
<b>Location/Ward</b>	Kimaeti		
<b>Date of Assessment</b>	01/03/2010		
<b>Total Funds Awarded to Date</b>	500,000		
<b>Total Funds Spent to Date</b>	500,000		
<b>Total Unaccounted Funds</b>	0		<b>Project Category</b> A
<b>Technical Performance Score</b>	83%		<b>Project Status</b> Complete and not in use
<b>Comments:</b> The classroom project was well implemented and reflects value for the amount of money allocated. Steel doors and windows were fitted. The fascia board was fitted and painted while support pillars were well spaced. Good value for the taxpayers' money.

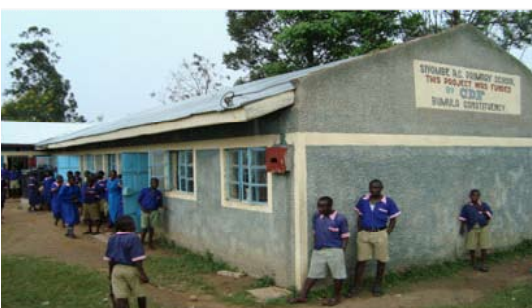
<b>Project Number</b>	CDF/B/099/2007-08

<b>Constituency</b>	Bumula		
<b>Project Name</b>	Nakhwana Primary School		
<b>Project Activity</b>	Construction of 2 Classrooms		
<b>Location/Ward</b>	Kimaeti		
<b>Date of Assessment</b>	03/03/2010		
<b>Total Funds Awarded to Date</b>	820,000		
<b>Total Funds Spent to Date</b>	820,000		
<b>Total Unaccounted Funds</b>	0		<b>Project Category</b> A
<b>Technical Performance Score</b>	76%		<b>Project Status</b> Complete and not in use
<b>Comments:</b> The project was well roofed, steel doors and windows were nicely fitted. The verandah was not constructed. Generally the project was well implemented and there is good value for the money.

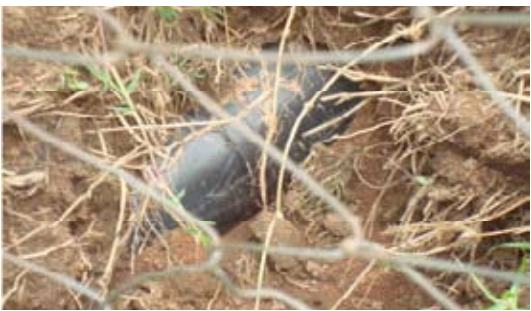
<b>Project Number</b>	CDF/B/106/2007-08

<b>Constituency</b>	Bumula				
<b>Project Name</b>	Musakasa electrification				
<b>Project Activity</b>	Power Supply				
<b>Location/Ward</b>	Napara				
<b>Date of Assessment</b>	12/07/2010				
<b>Total Funds Awarded to Date</b>	639,846				
<b>Total Funds Spent to Date</b>	639,846				
<b>Total Unaccounted Funds</b>	0			<b>Project Category</b>	B
<b>Technical Performance Score</b>	30%			<b>Project Status</b>	Complete and not in use
<b>Comments:</b> The community was not involved in the selection and implementation of the project. At the moment the power is not serving the majority of the community members. The community is not aware that it is a CDF project.

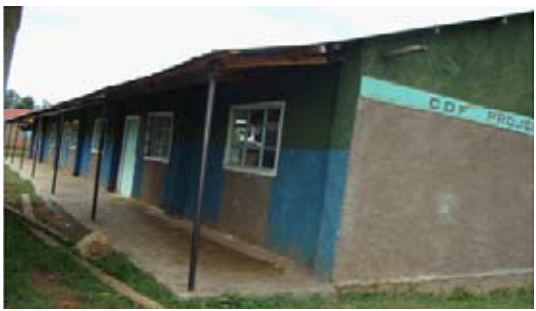
<b>Project Number</b>	CDF/B/002/2007-08

<b>Constituency</b>	Bumula				
<b>Project Name</b>	Kisioyi Primary School				
<b>Project Activity</b>	Construction of 2 Classroom and Administration Block.				
<b>Location/Ward</b>	Kibuke				
<b>Date of Assessment</b>	2/3/2010				
<b>Total Funds Awarded to Date</b>	700,000				
<b>Total Funds Spent to Date</b>	700,000				
<b>Total Unaccounted Funds</b>	0			<b>Project Category</b>	B
<b>Technical Performance Score</b>	43%			<b>Project Status</b>	Ongoing and in use
<p><b>Comments:</b> The project is not complete as plaster work has not been done, the fascia board is not fitted and there is no verandah. Additionally the doors and windows are not fitted. The roofing timber is not treated and ants are already chipping it away. The floor is covered with cow dung instead of cement. Although the children are using the facility, it is badly done. NTA was informed that land was also purchased.</p>

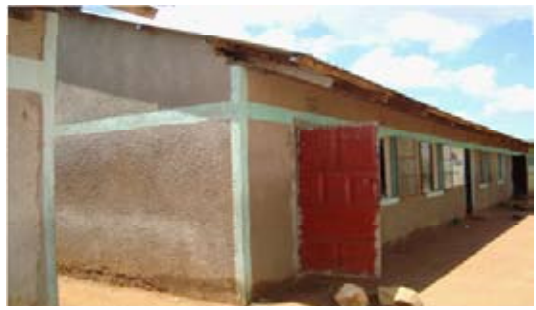
<b>Project Number</b>	CDF/B/004/2007-08

<b>Constituency</b>	Bumula		
<b>Project Name</b>	Wamunyiri R.C Primary School		
<b>Project Activity</b>	Construction of 3 classrooms		
<b>Location/Ward</b>	Kabula		
<b>Date of Assessment</b>	2/3/2010		
<b>Total Funds Awarded to Date</b>	620,000		
<b>Total Funds Spent to Date</b>	620,000		
<b>Total Unaccounted Funds</b>	0		<b>Project Category</b> C
<b>Technical Performance Score</b>	56%		<b>Project Status</b> Ongoing and in use
<b>Comments:</b> In this project the rough casting and the painting on walls was well done. The support pillars were also well erected on the verandah. The fascia board is not fixed and there are cracks on the floor. Despite the minor issues generally the project was well implemented.

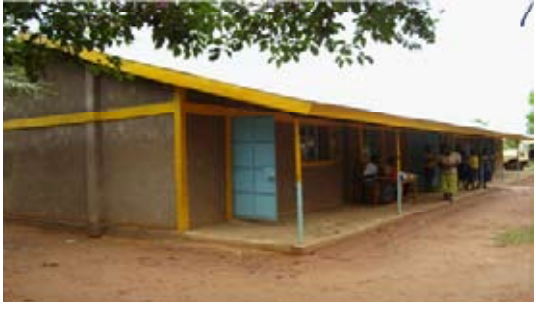
<b>Project Number</b>	CDF/B/005/2007-08

<b>Constituency</b>	Bumula		
<b>Project Name</b>	Mwiruti R.C Primary School.		
<b>Project Activity</b>	Construction of 3 classrooms		
<b>Location/Ward</b>	Kabula		
<b>Date of Assessment</b>	3/3/2010		
<b>Total Funds Awarded to Date</b>	620,000		
<b>Total Funds Spent to Date</b>	620,000		
<b>Total Unaccounted Funds</b>	0		<b>Project Category</b> C
<b>Technical Performance Score</b>	69%		<b>Project Status</b> Ongoing and in use
<b>Comments:</b> The project cost was within budget but it was under funded. The community contributed hard-core, bricks and unskilled labour. The classrooms have not been fitted with fascia board. There is no verandah. Steel doors and windows were properly fitted. There is fair workmanship as seen from finishes. Generally there is value for money though the project is incomplete.

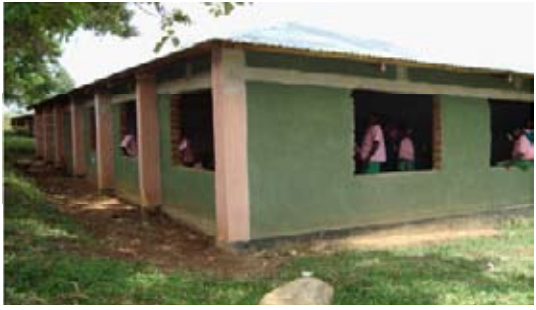
<b>Project Number</b>	CDF/B/006/2007-08

<b>Constituency</b>	Bumula		
<b>Project Name</b>	Malinda R.C Primary School		
<b>Project Activity</b>	Construction of 3 classrooms		
<b>Location/Ward</b>	Kabula		
<b>Date of Assessment</b>	26/2/2010		
<b>Total Funds Awarded to Date</b>	500,000		
<b>Total Funds Spent to Date</b>	500,000		
<b>Total Unaccounted Funds</b>	0		<b>Project Category</b> C
<b>Technical Performance Score</b>	66%		<b>Project Status</b> Ongoing and in use
<b>Comments:</b> The project was well implemented. The painting was well done, fascia board was nicely fixed and the support pillars are of good quality. The roofing was well done but the timber was not treated. At the time of NTA assessment the project was incomplete but will offer good value for the taxpayer once all the work is done satisfactorily.

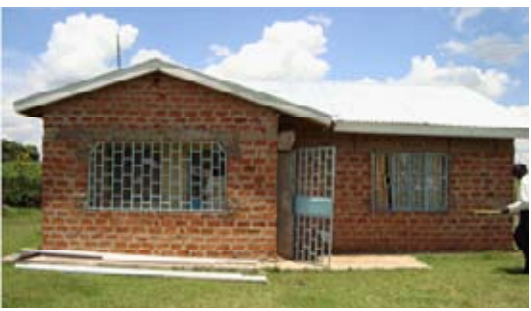
<b>Project Number</b>	CDF/B/012B/2007-08

**Comments:** Painting was well done and fascia board nicely fixed and painted. Steel doors and windows were well fitted. Although low quality iron sheet were used as evidenced by the rusting.

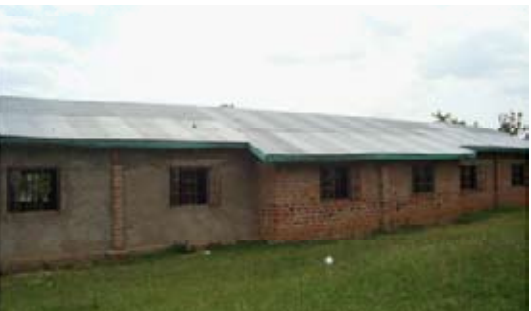
<b>Project Number</b>	CDF/B/018/2007-08

**Comments:** One of the classrooms is being used as a library. The verandah was well done. Noticeably the fascia board had cracks and the roofing poles used were not treated. The walls also have several visible cracks and the ventilators were not completed at the time of assessment.

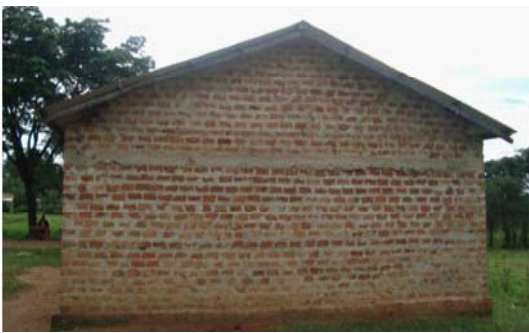
<b>Project Number</b>	CDF/B/020/2007-08

<b>Constituency</b>	Bumula		
<b>Project Name</b>	Nang'eni FYM Primary School		
<b>Project Activity</b>	Construction of 2 Classrooms and Admin office		
<b>Location/Ward</b>	Kibuke		
<b>Date of Assessment</b>	16/3/2010		
<b>Total Funds Awarded to Date</b>	650,000		
<b>Total Funds Spent to Date</b>	650,000		
<b>Total Unaccounted Funds</b>	0		<b>Project Category</b> C
<b>Technical Performance Score</b>	63%		<b>Project Status</b> Ongoing and in use

**Comments:** Although the project is fitted with fascia board, it is still under construction. Some windows have not been fitted and one classroom lacks window glass and plaster on the wall. The work done so far is satisfactory.

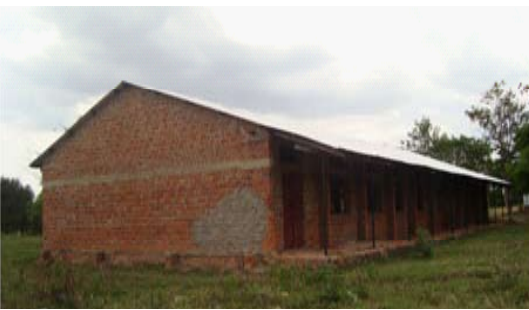
<b>Project Number</b>	CDF/B/023/2007-08

<b>Constituency</b>	Bumula		
<b>Project Name</b>	St. Nabuyeywe Primary School		
<b>Project Activity</b>	Construction Of 1 Classroom and Purchase Of Land		
<b>Location/Ward</b>	Kibuke		
<b>Date of Assessment</b>	2/3/2010		
<b>Total Funds Awarded to Date</b>	500,000		
<b>Total Funds Spent to Date</b>	500,000		
<b>Total Unaccounted Funds</b>	0		<b>Project Category</b> C
<b>Technical Performance Score</b>	66%		<b>Project Status</b> Ongoing and in use
<b>Comments:</b> Even though the materials used are of fair quality, the project is incomplete. So far no fascia board has been fitted and it has not been plastered. Doors and windows are yet to be fitted.

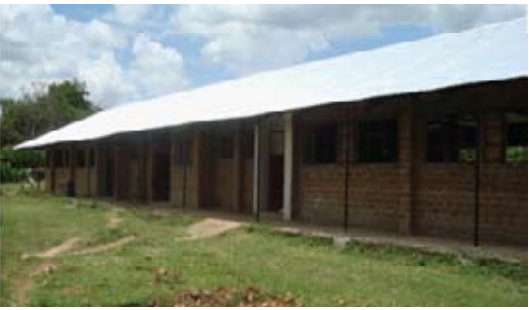
<b>Project Number</b>	CDF/B/024/2007-08

<b>Constituency</b>	Bumula		
<b>Project Name</b>	Nang'eni Secondary School		
<b>Project Activity</b>	Construction of Library		
<b>Location/Ward</b>	Kibuke		
<b>Date of Assessment</b>	16/3/2010		
<b>Total Funds Awarded to Date</b>	700,000		
<b>Total Funds Spent to Date</b>	700,000		
<b>Total Unaccounted Funds</b>	0		<b>Project Category</b> C
<b>Technical Performance Score</b>	79%		<b>Project Status</b> Ongoing and in use
<b>Comments:</b> So far the quality of materials being used are good quality. The support pillars used are made of steel, windows and doors are also made of steel although the window glass are yet to be fitted. There is good value for money for the community to the level of work done so far.

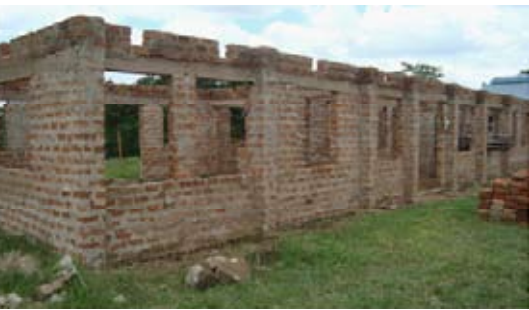
<b>Project Number</b>	CDF/B/026/2007-08

<b>Constituency</b>	Bumula		
<b>Project Name</b>	St. Kizito Mayanja Sec School		
<b>Project Activity</b>	Construction of a twin laboratory		
<b>Location/Ward</b>	Kibuke		
<b>Date of Assessment</b>	3/3/2010		
<b>Total Funds Awarded to Date</b>	800,000		
<b>Total Funds Spent to Date</b>	800,000		
<b>Total Unaccounted Funds</b>	0		<b>Project Category</b> C
<b>Technical Performance Score</b>	75%		<b>Project Status</b> Ongoing and in use
<b>Comments:</b> There are good support pillars and the iron sheets used for roofing are of good quality. Plastering has not been done, fascia board is not fitted. So far the project reflects good value and once completed will serve the community effectively.

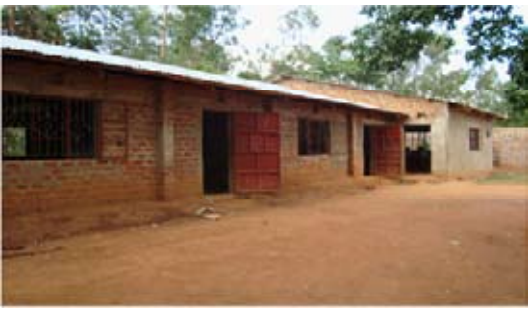
<b>Project Number</b>	CDF/B/029/2007-08

<b>Constituency</b>	Bumula		
<b>Project Name</b>	Kibuke Dispensary		
<b>Project Activity</b>	Construction of patient rooms		
<b>Location/Ward</b>	Kibuke		
<b>Date of Assessment</b>	3/3/2010		
<b>Total Funds Awarded to Date</b>	1,100,000		
<b>Total Funds Spent to Date</b>	1,100,000		
<b>Total Unaccounted Funds</b>	0		<b>Project Category</b> C
<b>Technical Performance Score</b>	66%		<b>Project Status</b> Ongoing and not in use
<b>Comments:</b> Work is ongoing on this project. There is good mixing ratio of the materials used and good workmanship is displayed. The project status reflects good value for money for the community so far.

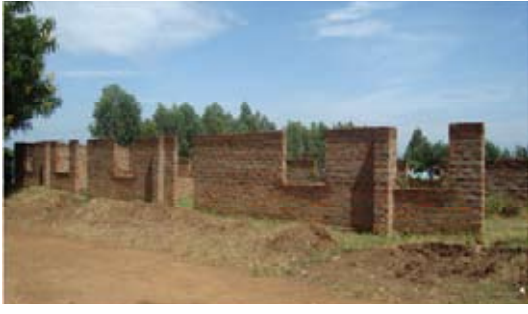
<b>Project Number</b>	CDF/B/033/2007-08

<b>Constituency</b>	Bumula				
<b>Project Name</b>	Kibachenje Primary School				
<b>Project Activity</b>	Construction of 3 classrooms				
<b>Location/Ward</b>	South Bukusu				
<b>Date of Assessment</b>	24/2/2010				
<b>Total Funds Awarded to Date</b>	620,000				
<b>Total Funds Spent to Date</b>	620,000				
<b>Total Unaccounted Funds</b>	0			<b>Project Category</b>	C
<b>Technical Performance Score</b>	66%			<b>Project Status</b>	Ongoing and in use
<b>Comments:</b> The classrooms are fitted with steel doors and windows but no panes. The plastering has not been done, no verandah and the fascia board is not fitted. At this level of implementation the project represents value for money and demonstrates good workmanship in construction.

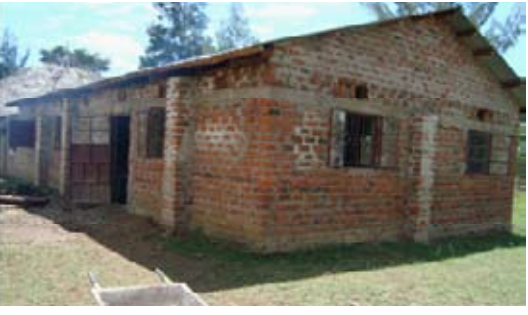
<b>Project Number</b>	CDF/B/035/2007-08

<b>Constituency</b>	Bumula				
<b>Project Name</b>	Burangasi Primary School.				
<b>Project Activity</b>	Construction of 2 Classrooms				
<b>Location/Ward</b>	South Bukusu				
<b>Date of Assessment</b>	3/3/2010				
<b>Total Funds Awarded to Date</b>	620,000				
<b>Total Funds Spent to Date</b>	620,000				
<b>Total Unaccounted Funds</b>	0			<b>Project Category</b>	C
<b>Technical Performance Score</b>	66%			<b>Project Status</b>	Ongoing and not in use
<b>Comments:</b> The project is in progress. Walling done up to lintel level. The wall looks plumb and the joints well fitted with mortar. Once complete it will have value for money for the taxpayer. Important to note though is that the project cost is higher than the work done so far.

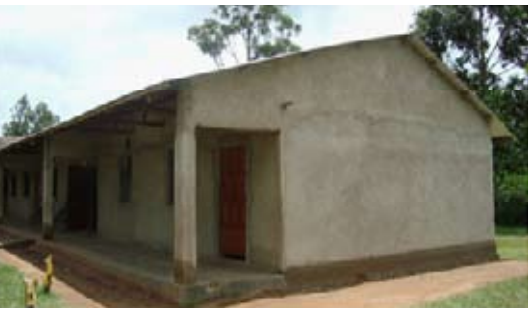
<b>Project Number</b>	CDF/B/051/2007-08

<b>Constituency</b>	Bumula				
<b>Project Name</b>	Lumboka Memorial Sec. School				
<b>Project Activity</b>	Construction of Kitchen/DH				
<b>Location/Ward</b>	South Bukusu				
<b>Date of Assessment</b>	23/2/2010				
<b>Total Funds Awarded to Date</b>	800,000				
<b>Total Funds Spent to Date</b>	800,000				
<b>Total Unaccounted Funds</b>	0			<b>Project Category</b>	C
<b>Technical Performance Score</b>	56%			<b>Project Status</b>	Ongoing and in use
<b>Comments:</b> For this project plastering has not been done although it has good support columns. The level of workmanship should be improved. The project represents good value for the community at this level.

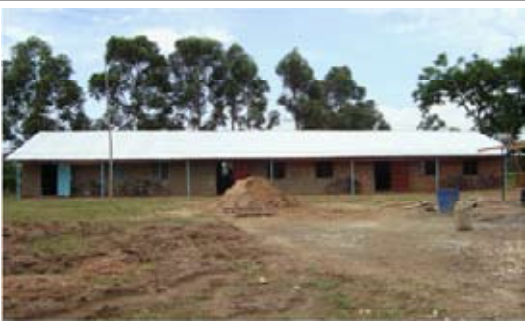
<b>Project Number</b>	CDF/B/037/2007-08

<b>Constituency</b>	Bumula				
<b>Project Name</b>	Khayo MMK Primary School				
<b>Project Activity</b>	Construction of 2 Classrooms				
<b>Location/Ward</b>	Mabusi				
<b>Date of Assessment</b>	1/3/2010				
<b>Total Funds Awarded to Date</b>	500,000				
<b>Total Funds Spent to Date</b>	500,000				
<b>Total Unaccounted Funds</b>	0			<b>Project Category</b>	C
<b>Technical Performance Score</b>	69%			<b>Project Status</b>	Ongoing and in use
<b>Comments:</b> This project is ongoing. The classrooms have not been painted and fitted with fascia board. The timbers used for roofing are not treated. There was cracking around doors, windows and on the floor demonstrating some weakness in workmanship. Generally the funds allocated were well utilized.

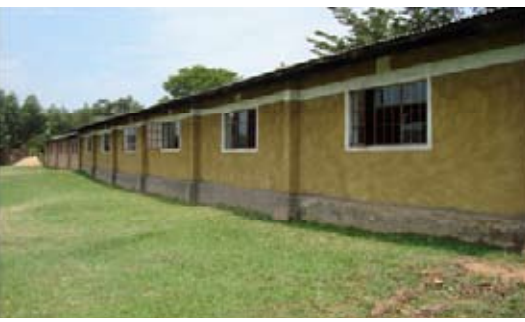
<b>Project Number</b>	CDF/B/041/2007-08

<b>Constituency</b>	Bumula		
<b>Project Name</b>	St. Mary's Kimatuni		
<b>Project Activity</b>	Construction of 3 classrooms		
<b>Location/Ward</b>	South Bukusu		
<b>Date of Assessment</b>	24/2/2010		
<b>Total Funds Awarded to Date</b>	850,000		
<b>Total Funds Spent to Date</b>	850,000		
<b>Total Unaccounted Funds</b>	0		<b>Project Category</b> C
<b>Technical Performance Score</b>	59%		<b>Project Status</b> Ongoing and in use
<b>Comments:</b> The roofing of the classrooms was well done. The support pillars are well erected and the classrooms fitted with steel doors and windows. Fascia board is not fixed and the plastering has not yet been done. The level of work done so far is good value for taxpayers money

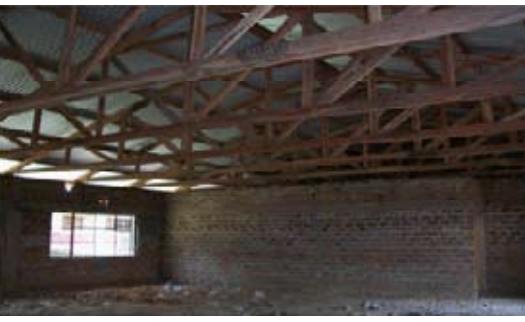
<b>Project Number</b>	CDF/B/043/2007-08

<b>Constituency</b>	Bumula		
<b>Project Name</b>	Kabubero Primary School		
<b>Project Activity</b>	Construction of 4 classrooms		
<b>Location/Ward</b>	Mukwa		
<b>Date of Assessment</b>	26/08/2010		
<b>Total Funds Awarded to Date</b>	620,000		
<b>Total Funds Spent to Date</b>	620,000		
<b>Total Unaccounted Funds</b>	0		<b>Project Category</b> C
<b>Technical Performance Score</b>	56%		<b>Project Status</b> Ongoing and in use
<b>Comments:</b> The construction of the verandah has not been done. There are no support pillars and the fascia board is not fitted. Rough casting is well done and the roof is well erected although it has been done using poles that are not treated.

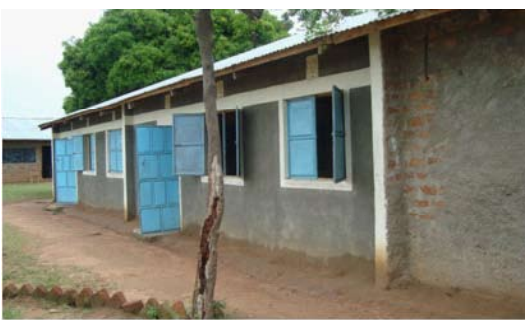
<b>Project Number</b>	CDF/B/046/2007-08

<b>Constituency</b>	Bumula		
<b>Project Name</b>	St. Paul Miluki Secondary School		
<b>Project Activity</b>	Payment of School debt and construction of Lab		
<b>Location/Ward</b>	Mukwa		
<b>Date of Assessment</b>	13/09/2010		
<b>Total Funds Awarded to Date</b>	800,000		
<b>Total Funds Spent to Date</b>	800,000		
<b>Total Unaccounted Funds</b>	0		<b>Project Category</b> C
<b>Technical Performance Score</b>	82%		<b>Project Status</b> Ongoing and in use
<b>Comments:</b> Ksh.300,000/= out of the allocated money was used for the offsetting a balance for the school bus. The remaining funds were used to construct a physics laboratory which is still ongoing. It was observed that so far quality materials are being used to do the work and steel windows have been fitted although without panes.

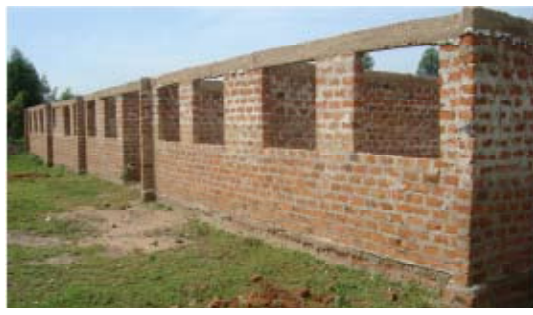
<b>Project Number</b>	CDF/B/056/2007-08

**Comments:** The project involves construction of a dining hall but is yet to be completed. No glass have been fitted on the windows and the fascia board and painting yet to be done. Plaster work was incomplete. Good workmanship as observed on the plaster and roof.

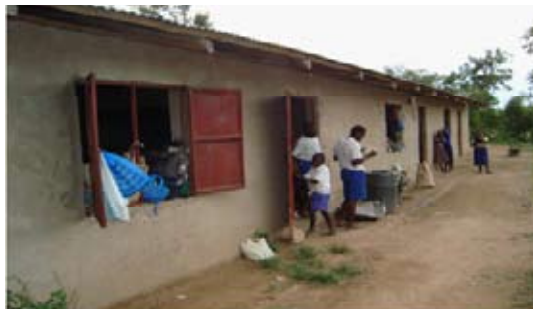
<b>Project Number</b>	CDF/B/060/2007-08

<b>Constituency</b>	Bumula		
<b>Project Name</b>	Nasianda Dispensary		
<b>Project Activity</b>	Health Centre		
<b>Location/Ward</b>	Mabusi		
<b>Date of Assessment</b>	25/02/2010		
<b>Total Funds Awarded to Date</b>	800,000		
<b>Total Funds Spent to Date</b>	800,000		
<b>Total Unaccounted Funds</b>	0		<b>Project Category</b> C
<b>Technical Performance Score</b>	54%		<b>Project Status</b> Ongoing and not in use

**Comments:** The site of the project is clean, the workmanship displayed is good and there is a value for money so far. Good quality materials are being used in the construction. Once complete this can be a good project.
